**ATE' FRONT BRAKE CALIPER HOUSING O-RINGS  
(Replacement)**

**Application: 1981 BMW R65**

**By: Mike Valenti / ABC#11027**

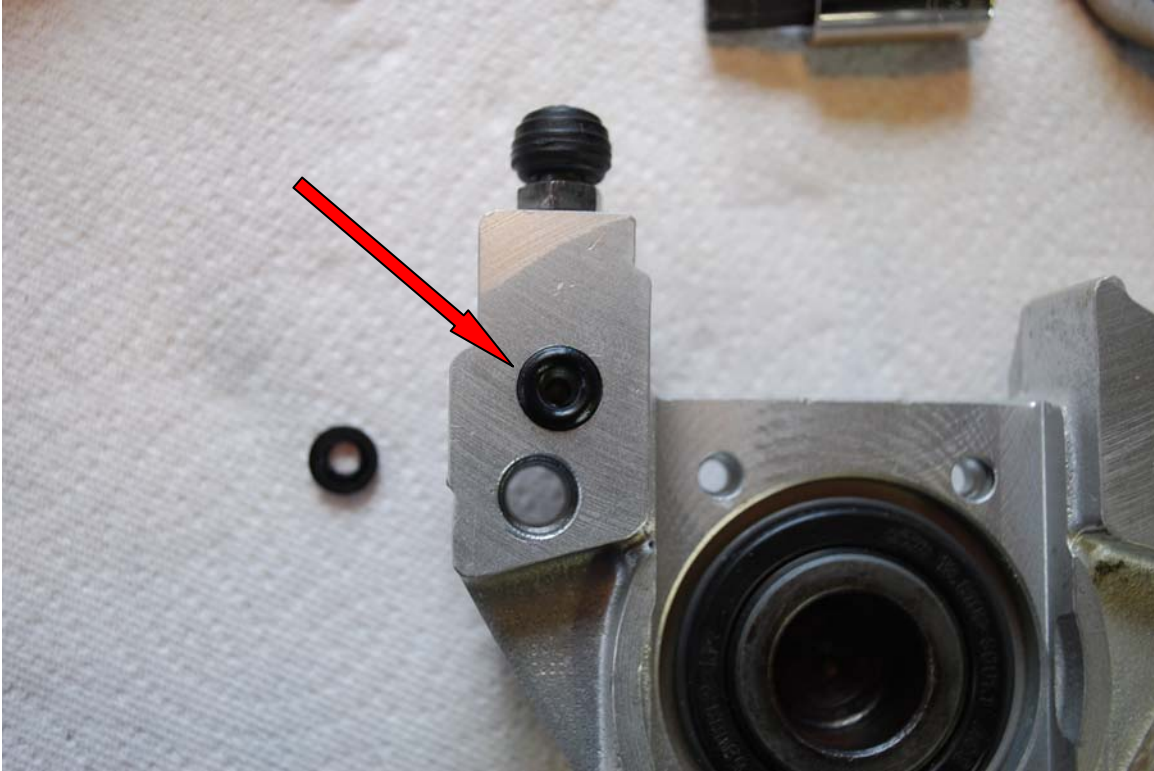
## EPDM O-Ring

This O-ring in my personal opinion was an adequate fit in the bore of the caliper allowing its outer most limits to rest inside of the recessed port with no overlap and adequate compression extension for sealing. And in addition, the inner opening of the O-ring allowed adequate fluid flow with no restriction to the gallery port. The thickness of the O-ring was acceptable with what I would estimate to be approximately 0.5 mm of production above the milled surface of the caliper allowing for compression in-between the two caliper halves for sealing. I was able to locate metric square EPDM O-rings by a few other Industrial suppliers but the cost in comparison to the round O-rings supplied by McMaster-Carr were exorbitant and not economically feasible for my specific application.

The above photo illustrates the complete overall coverage of the gallery port bore with the subject O-Ring which by visual observation seems to be a perfect fit. In the left background is the original Square O-Ring.
