Clutch disk replacement and transmission input spline lubrication

The following outlines the steps that I took when removing the transmission from my 1982 R65LS and replacing the clutch disk – I also ended up replacing the transmission with a rebuilt unit as the input shaft splines had been heavily damaged from the clutch spline failure experienced on the road and under power. These same basic steps (but stopping short of disassembling and removing the clutch carrier assembly) can be used for performing regular transmission input shaft spline lube. I would recommend that a proper spline lube be performed on any BMW airhead at least every 3-4 years or 20K miles, or perhaps more frequently if operation in severe conditions is common. If you have a “new” bike without recent documentation history of having this done, or you buy a bike (which may still have very low mileage) which has been stored for years, I would recommend doing this as soon as possible.

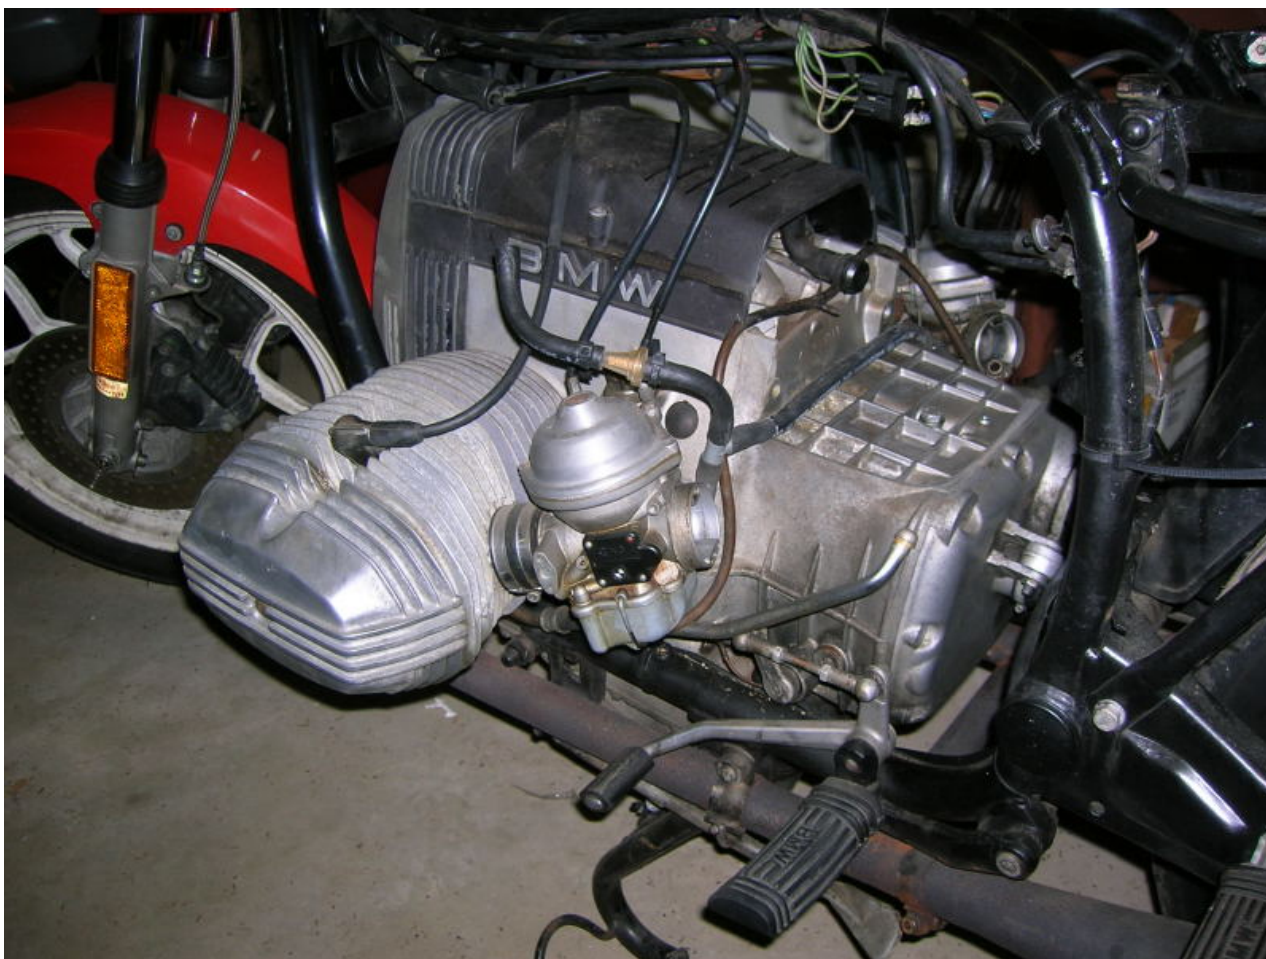
<insert clutchjob01.jpg>

First, we remove the seat and fuel tank – you might leave these on if you prefer, but we must take off the air filter assembly and the remove the battery and battery box out of the way, so to improve access to these items I just remove the fuel tank and seat as a practical matter. I won't go into the specific details of removal for these items as it isn't too complicated and the removal of these items are also covered in other articles. Along with removing the airbox, we remove the “horns” or elbows from the airbox into the carbs. The photo here shows the fuel line crossover and vacuum lines still in place at this stage, but they must also be removed/moved out of the way.

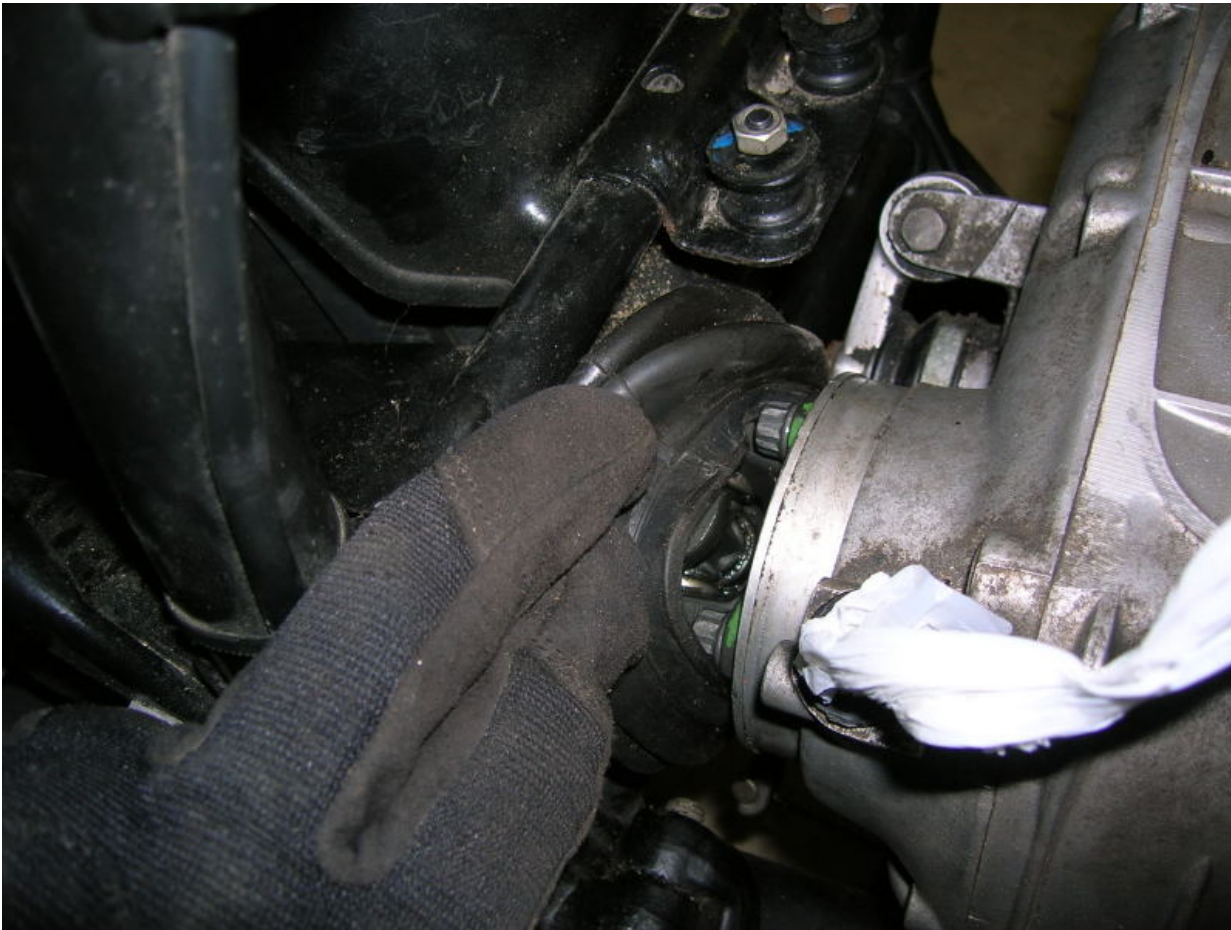
<insert clutchjob05.jpg>

Next, remove the front clamp that holds the front of the large rubber swingarm boot to the back of the transmission. We do this so we can access the (4) 12-point driveshaft bolts that are inside and remove them. It is a small area, but the thin BMW closed end 12-point wrench in the standard toolkit works well for getting in there and removing these. Step down hard on the rear brake pedal and/or have an assistant help you hold the rear wheel. If your clutch disk splines aren't destroyed you might also find it helpful to put the bike in gear as well to provide resistance to driveshaft rotation as you firmly set the wrench on the bolt head and give it a good pull to loosen. Then slowly rotate the rear wheel (take bike out of gear again if necessary) to the next bolt and loosen it. Go through all (4) bolts. Once you've loosened them all you can unscrew them the rest of the way and remove with your fingers. The OLD fashioned bolts have split lockwashers and are longer (to accommodate for the lockwasher thickness) while the NEW style bolts have no lockwashers and are stretch bolts. I would definitely recommend using new bolts when it is time to put everything back together, especially if the ones you took out were stretch bolts. I've been able to do this while basically keeping the rubber boot still loosely clamped to the swingarm to facilitate getting everything back together again.

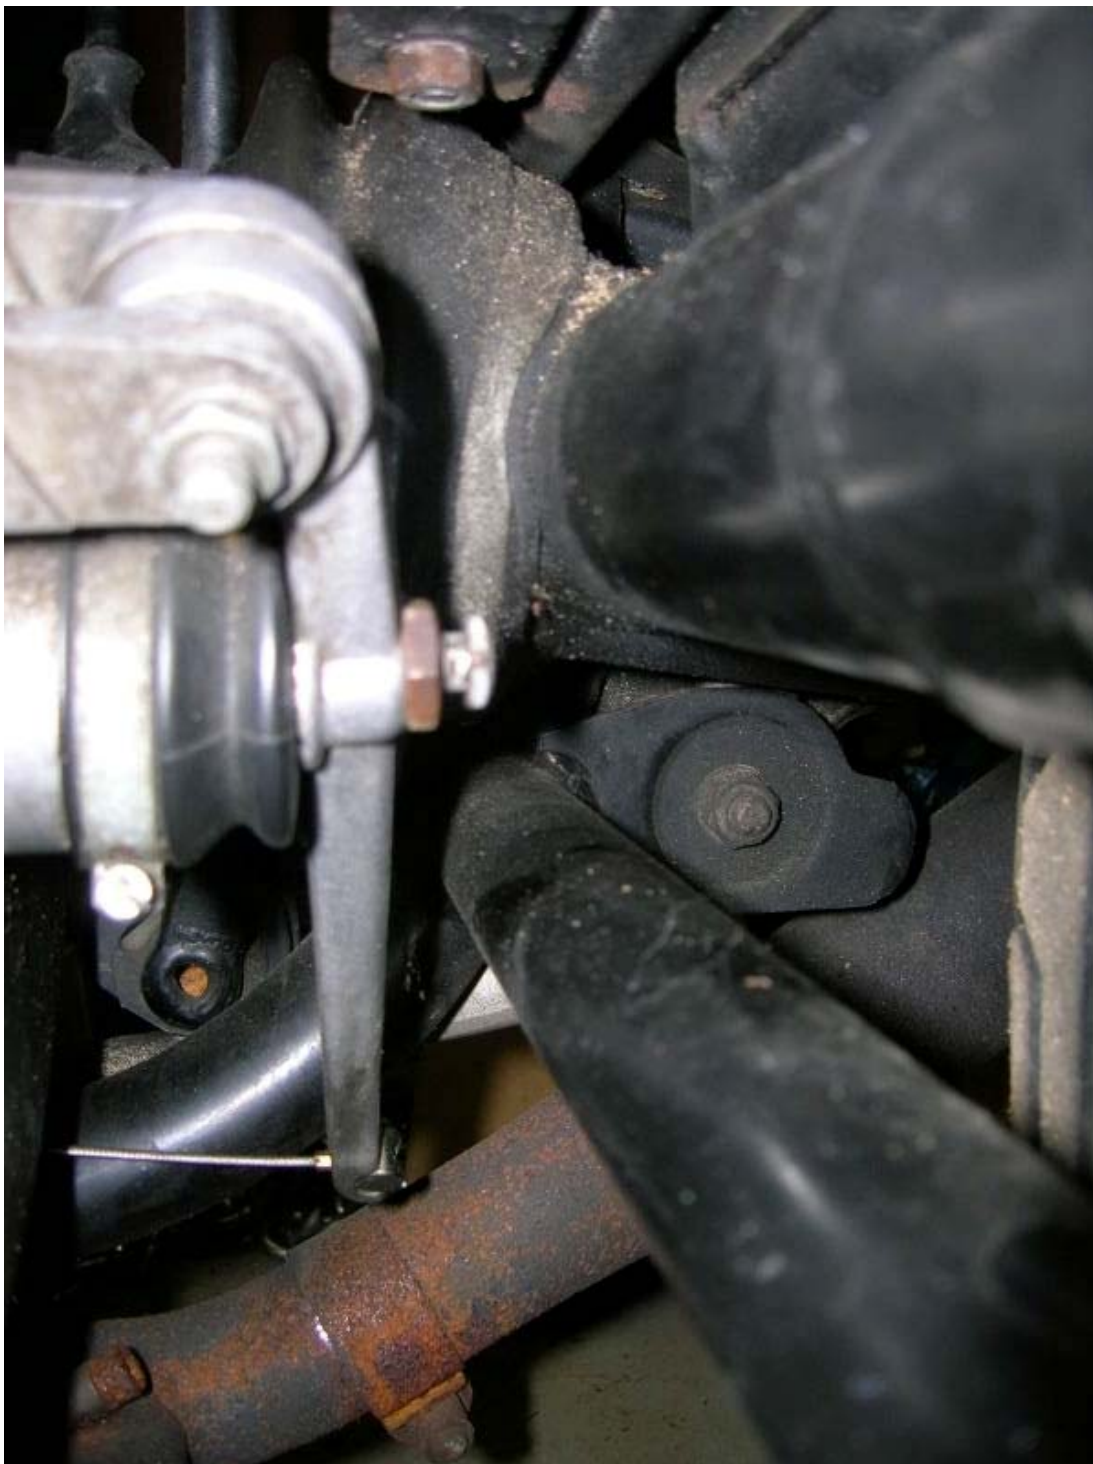
<insert clutchjob06.jpg>

Now, I am going to skip ahead just a bit to show you the most that you can possibly hope for as far as seeing/accessing the transmission shaft input splines if you try to cut corners and don't pull the swingarm back and pull the transmission out. Here you can see that if we don't move the swingarm back, the "ears" that the clutch actuating lever pivot in (part of the back cover of the transmission) will contact the swingarm tube in a little over an inch of travel.

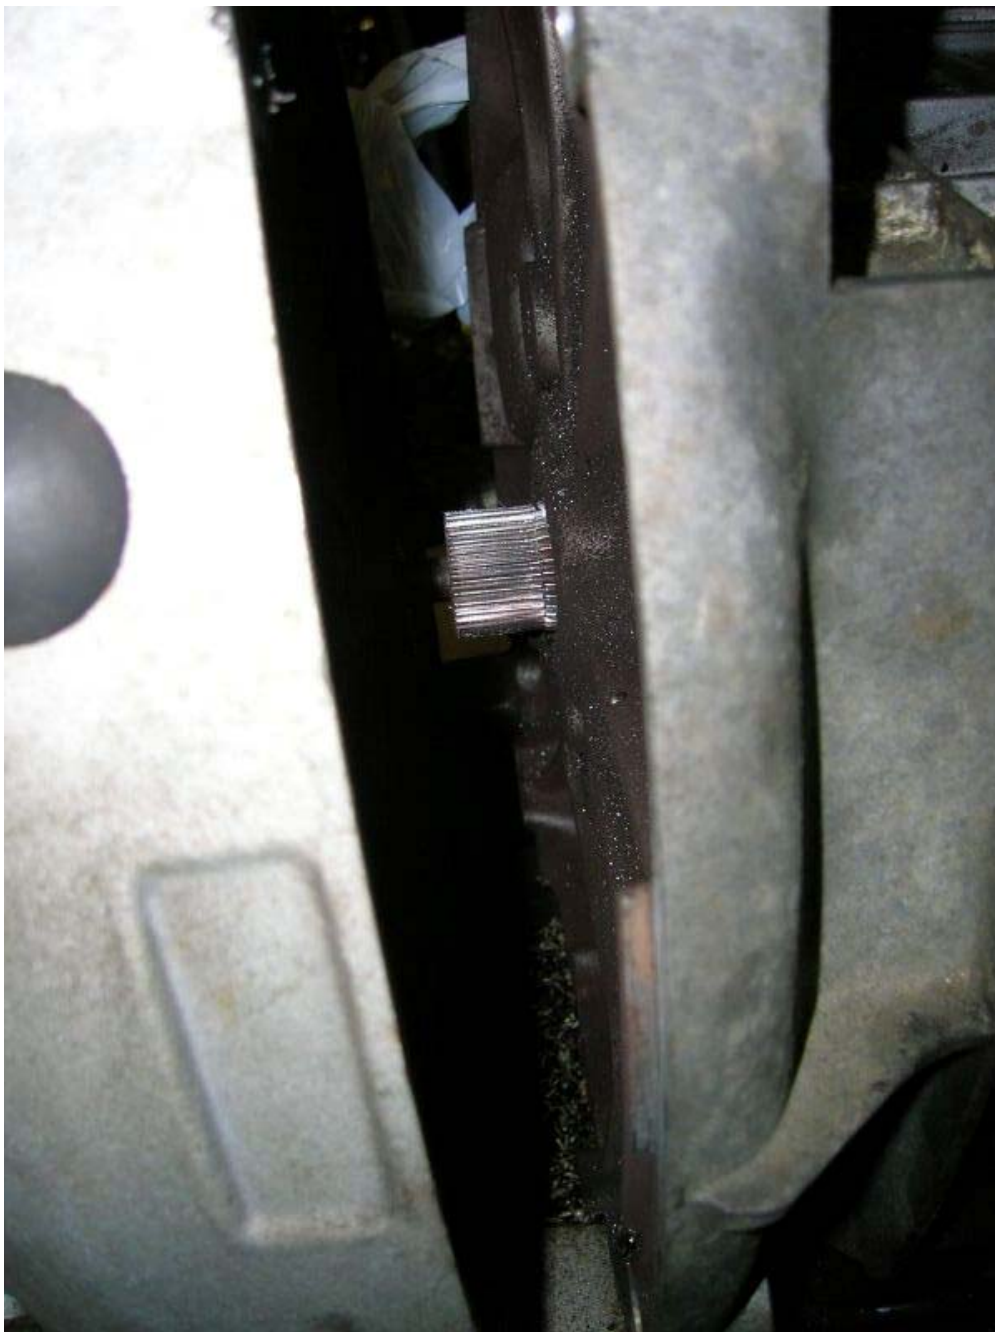
<insert clutchjob07.jpg>

It would not be easy to even get this much visibility (photo taken from near the timing hole on left side of engine case). As you can see here on this bike, significant damage/wear to the input shaft splines is evident, with lots of shiny metal particles. There shall be no cutting corners on this job !

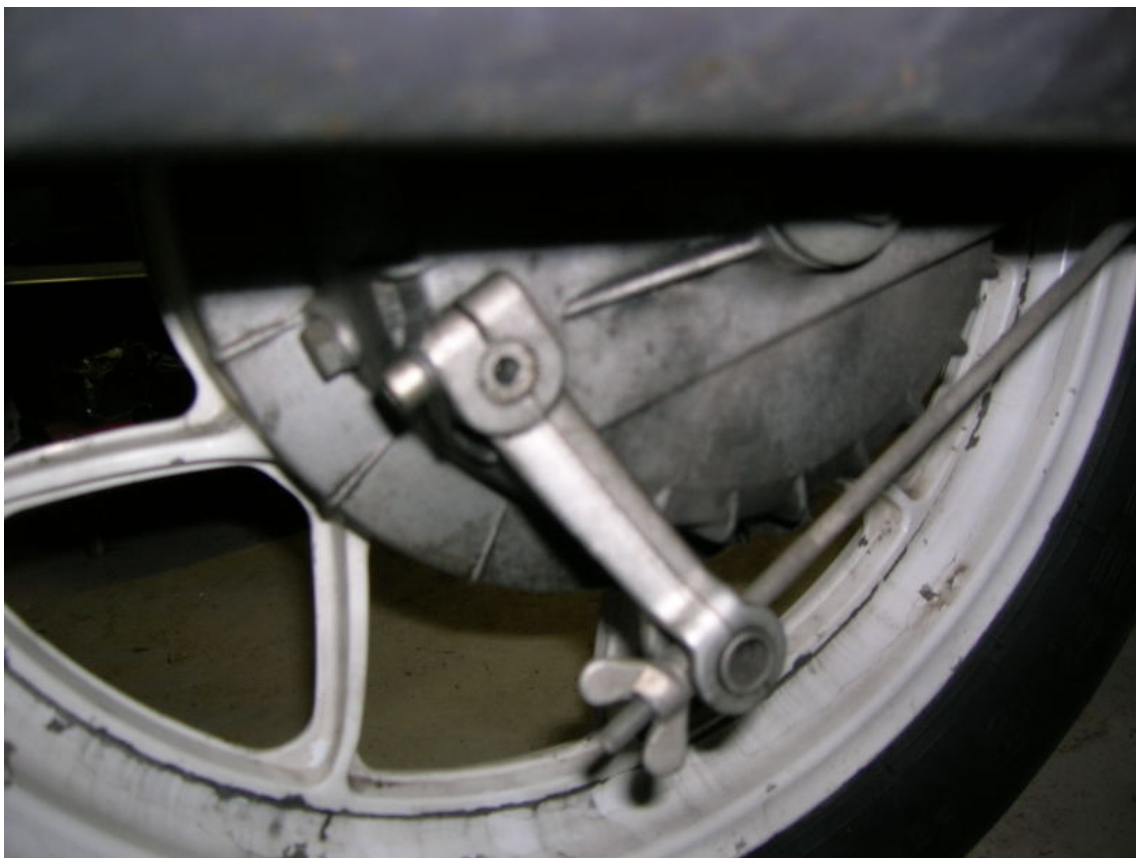
<insert clutchjob08.jpg>

Next, I remove the wingnut at the rear brake actuating rod – before you do take a digital picture or make a note of about how many threads it is screwed in so you can easily get it back to where it ought to be on reassembly. I then let the brake rod hang. I then remove the rear brake lever mount for freeing up the swingarm to move backward. (but will keep the lever, rod, etc. all attached). You can also loosen – but do not remove- the bolts that connect the top and bottom of the rear shock absorbers on both sides – this will make things “swing” more freely when we pull the swingarm back.

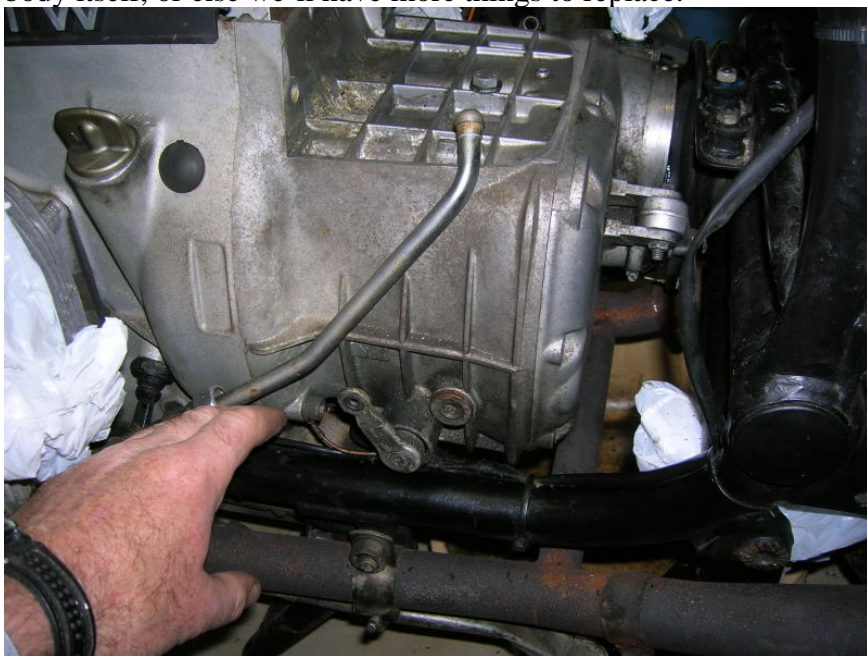
<insert clutchjob09.jpg>

Moving back over to the left side of the bike, I must disconnect and remove the shift lever linkage from the transmission. I then remove the left side footpeg and entire shift lever assembly. This will give us needed clearance to remove the transmission from this (left) side of the bike. Also take note that there is a ground wire connection at the lower left Allen bolt which also holds the transmission onto the engine. Near this bolt, but on the underside of the transmission is the neutral switch with (2) wires going to it – we must be careful when we remove the transmission to first disconnect the wires and not break the tabs on the switch or the plastic switch body itself, or else we'll have more things to replace.

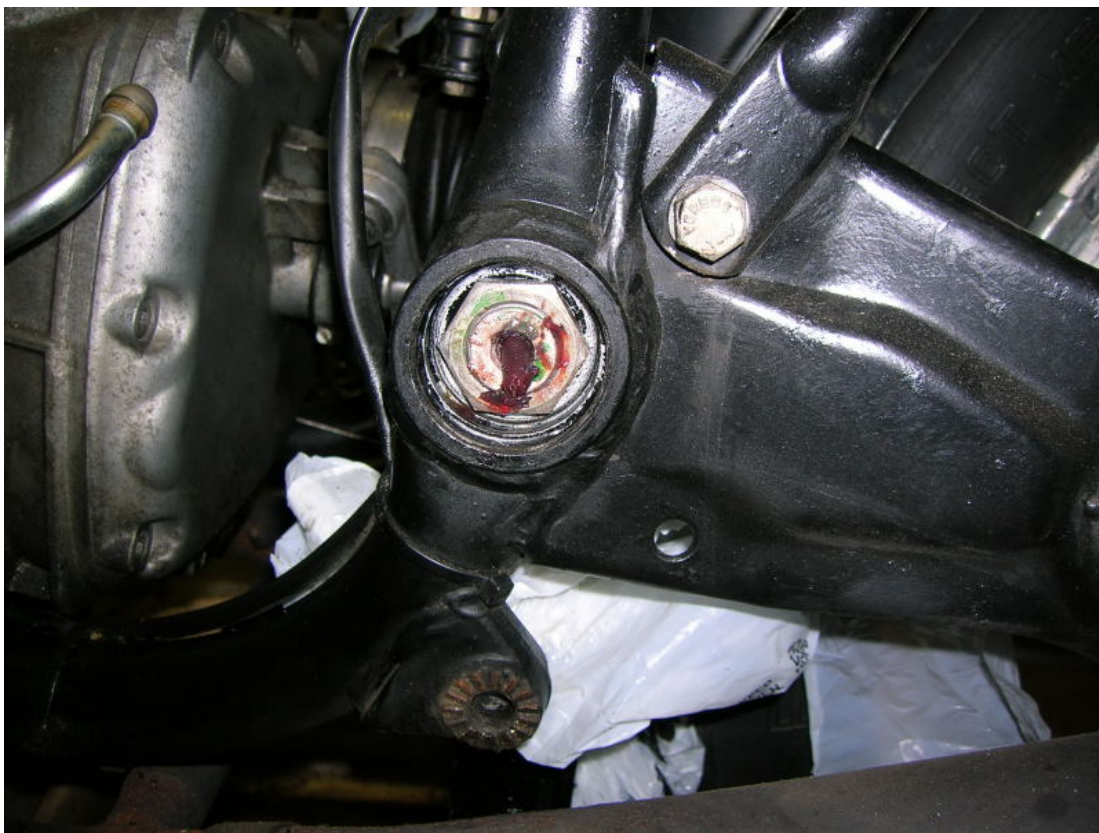
<insert clutchjob11.jpg>

Now, pry off the plastic end caps which cover the swingarm pivots. You will need to use a modified 27mm socket to loosen the retaining nuts. A thin-walled Sears Craftsman socket might work without modification, I have been told, but I use a modified socket to ensure that the socket gets a good solid grip on the nuts, which do have to be tightened to a reasonable torque. Once the nuts are loosened by a few turns, I take an Allen wrench and insert it into the center hole of the swingarm pivot pin and unscrew it. We will do this on each side – be aware that the swingarm may very well decide to move (swing) when you remove the second pin.

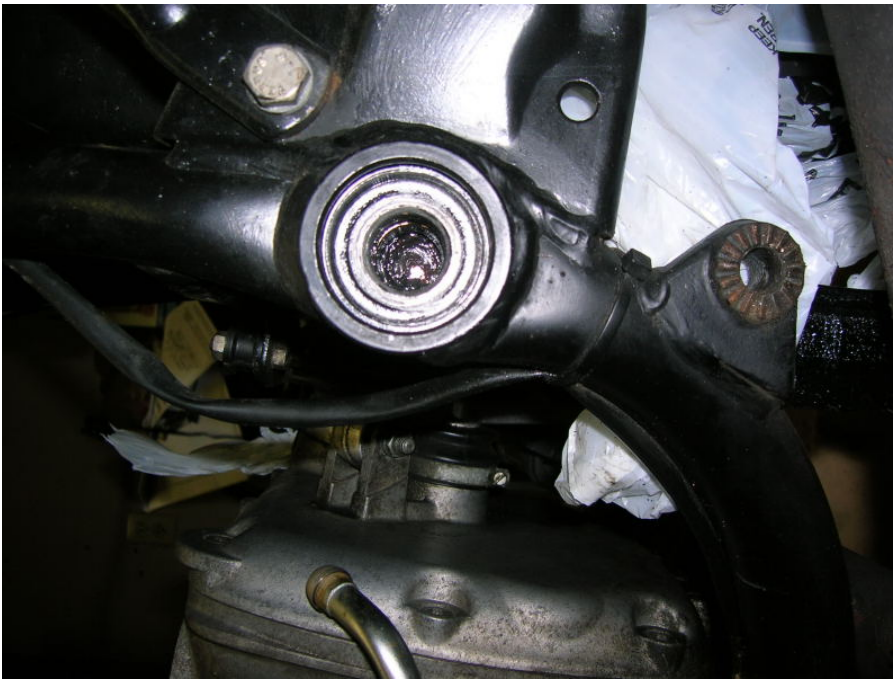
<insert clutchjoba01.jpg>

Swingarm lock nut and pivot pin removed:

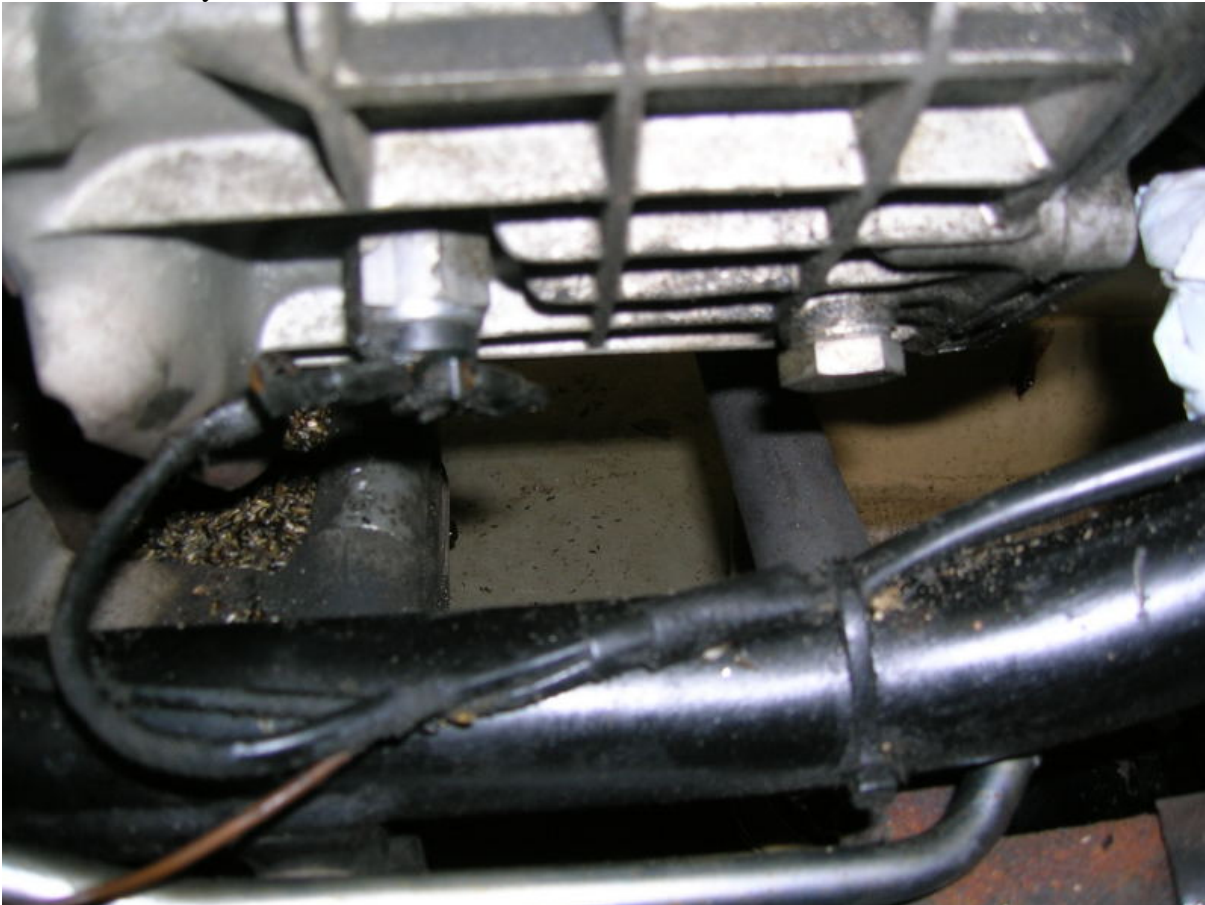
<insert Clutchjob13.jpg>

There are (4) bolts holding the transmission to the engine case: (2) are toward the top and revealed/removed when we remove the air box. The remaining two are Allen bolts on the lower left and right hand side of the transmission case. Remove these (2) bolts, noting that the left and right side bolts are different lengths. The transmission may remain somewhat “stuck” against the engine case, or it may pull easily back. A tap or two with a rubber mallet may free it. You may need help in holding the transmission (it is heavy) as you slide it slowly straight back for an inch or so, then rotate it slightly clockwise so that the neutral switch on the left underside is exposed. Disconnect the (2) wires from the switch and be careful not to damage the tabs on the switch. When you do remove the transmission be careful to not set it down where the switch may be damaged.

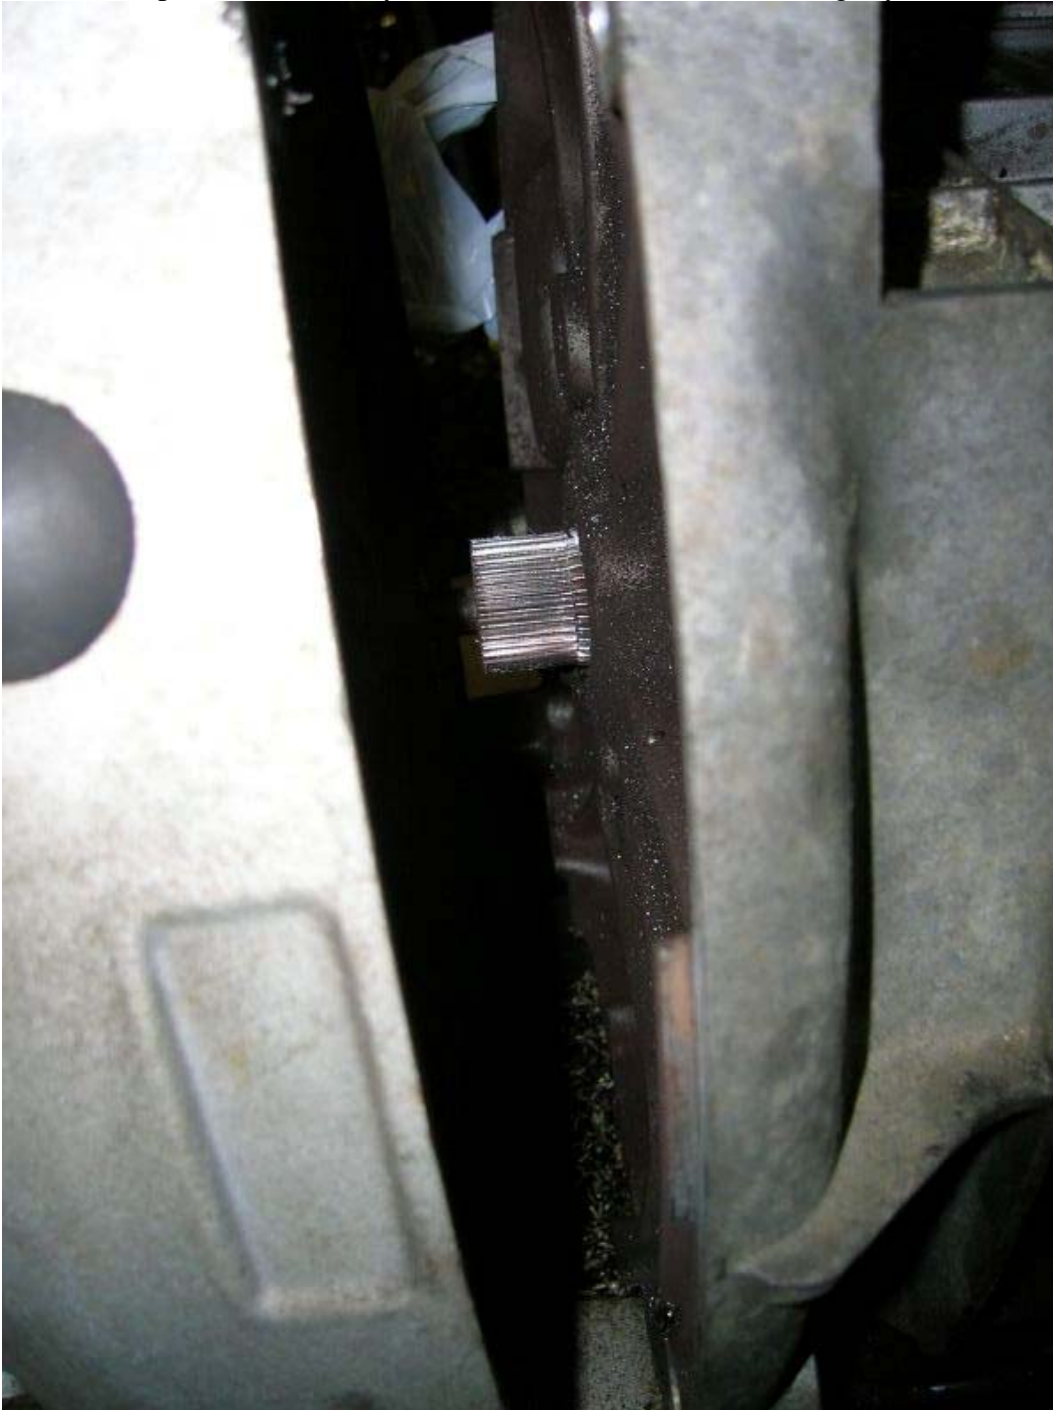
<insert clutchjob14.jpg>

To get the transmission out, we have the transmission slid backward between 1-2 inches and slightly rotated clockwise. This will get the transmission input shaft splines free of the clutch assembly. But, if you didn't pull the pushrod back already, use some long-nosed pliers to reach in there and grasp the pushrod, and use them to slide the pushrod back toward the rear of the transmission. Have a helper ready to catch the actuating piston and throwout bearing which may be forced out the back of the transmission when the tip of the rod goes into the input shaft. It is hard to see the pushrod in this pic, but it does exit the center of the splined shaft and may extend another 1-2 inches into the clutch assembly at this stage. It was a bit challenging holding the transmission with one hand and taking a pic with the other, but you'll get the idea. Once the pushrod tip is back inside the input shaft, carefully lift and rotate the transmission slightly so that it exits the left side of the frame.

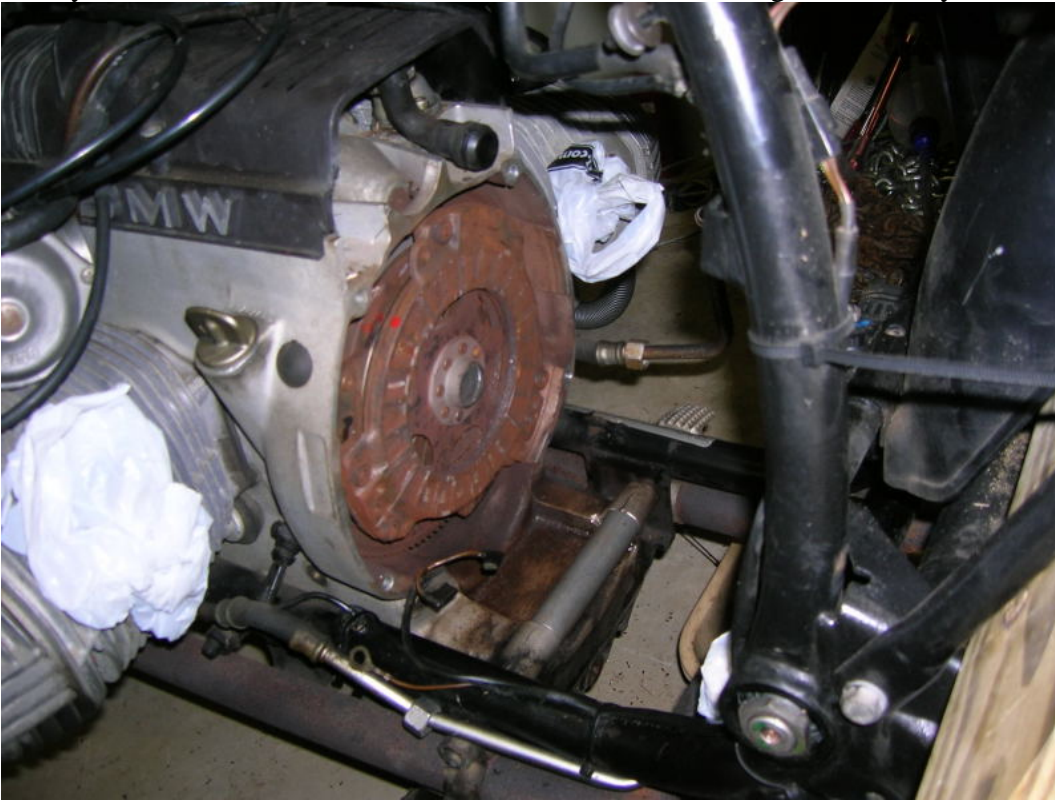
<insert clutchjob15.jpg>

Now you have the transmission out, it should look something like this, if you have an 1981 or later airhead:

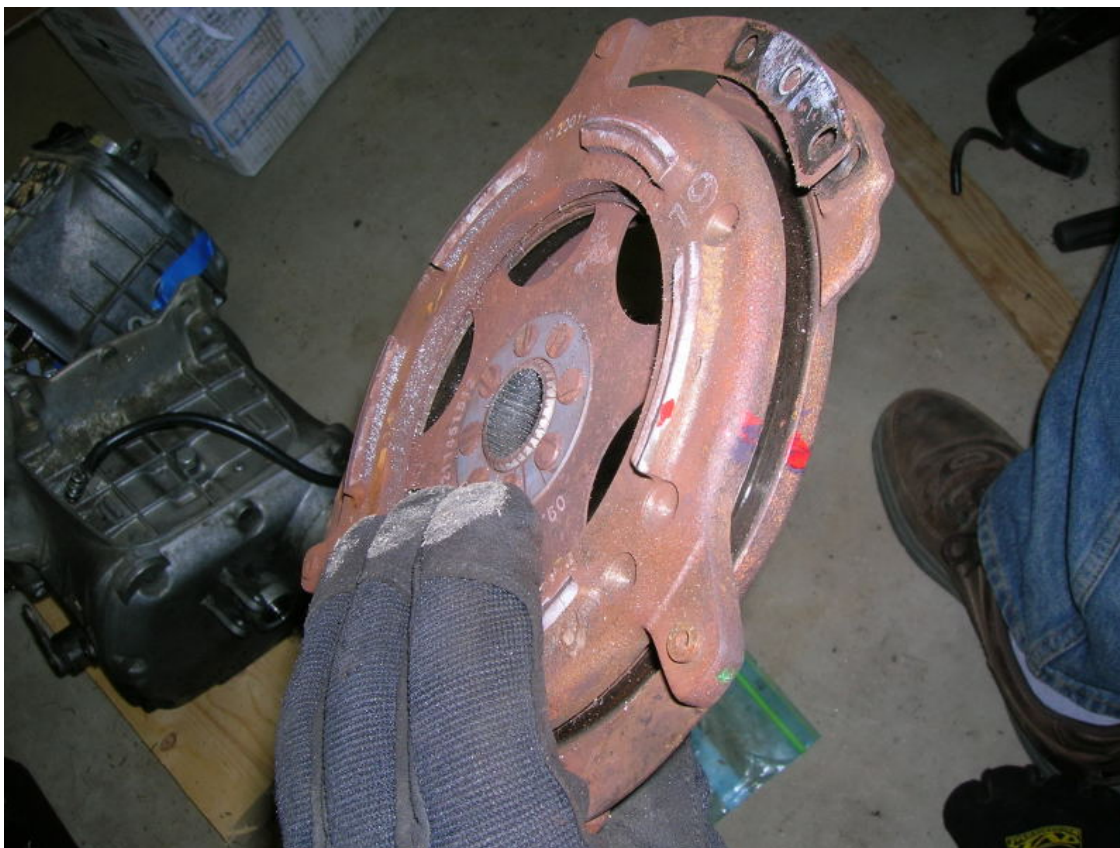
<insert clutchjob16.jpg>

The (very rusty, clutch assembly with destroyed friction disk splines that came off:

I cleaned up the various parts, took some measurements and determined that the spring, clutch plate, and cover were all still perfectly serviceable (and had less than 15K miles on them), but of course, the friction plate/disk HAD to be replaced. I had acquired another set of lightly used clutch parts with less than 10K miles on them and the friction plate had good clean splines, so I decided to use my original parts with the “new” friction plate.

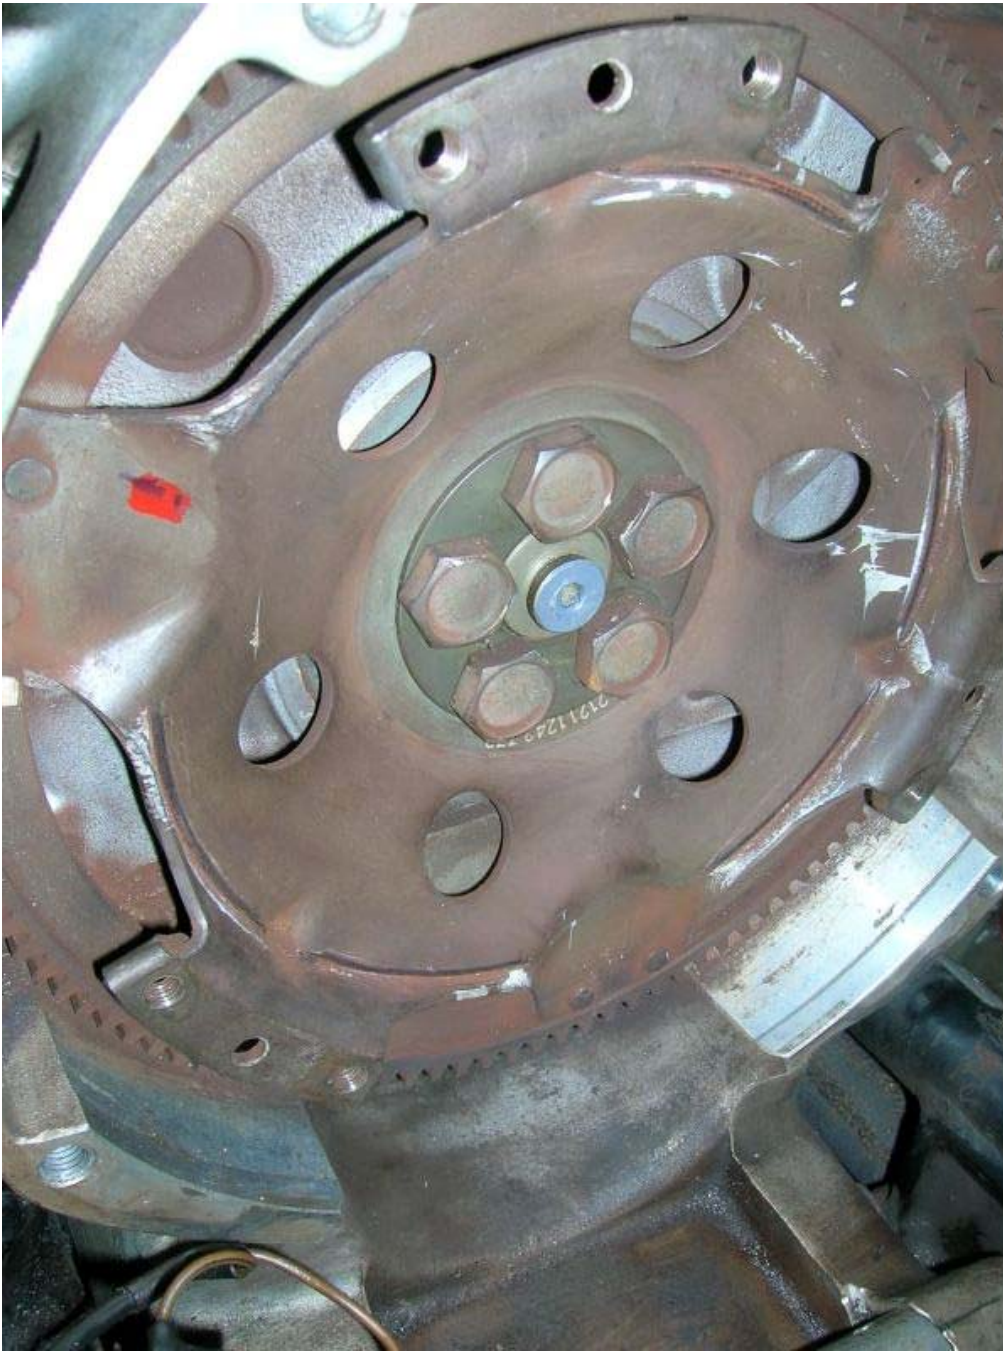
<insert ClutchJob17.jpg>

While we have the transmission and clutch assembly out, we have good access and view around the flywheel and bell housing. Look carefully for signs of oil leakage from behind the flywheel. Oils leaks can come from either a leaking rear main seal (seal goes around the end of the crankshaft) or from the oil pump cover (the cover is immediately below the end of the crank). If there is an oil leak we must remove the flywheel (which has some other important ramifications) to work on it – fortunately, this isn't needed at this time.

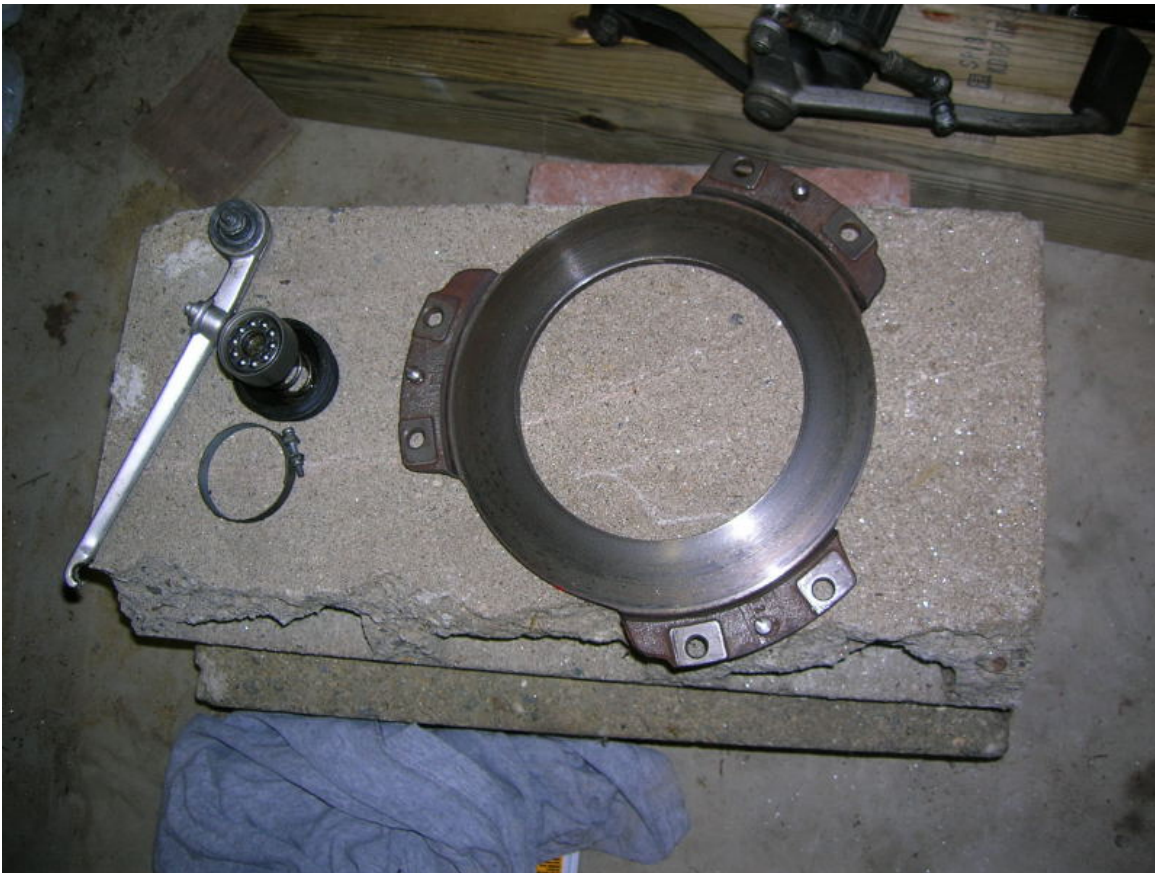
<insert Clutchjob19.jpg>

Here is the clutch cover plate (you see the clutch actuating arm, piston, throwout bearing and pushrod parts on the left – we'll get to that later.

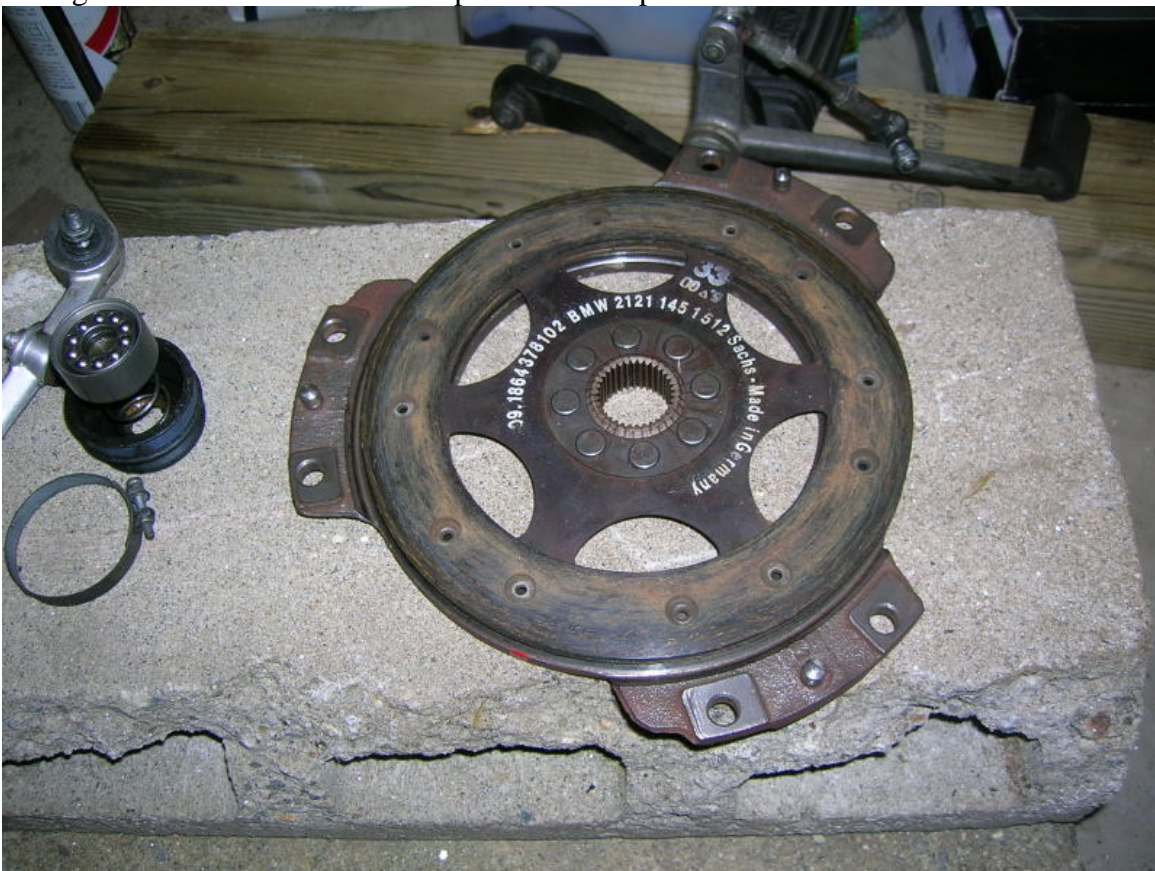
<insert Clutchjob20.jpg>

Next goes on the friction disk on top of the cover plate.

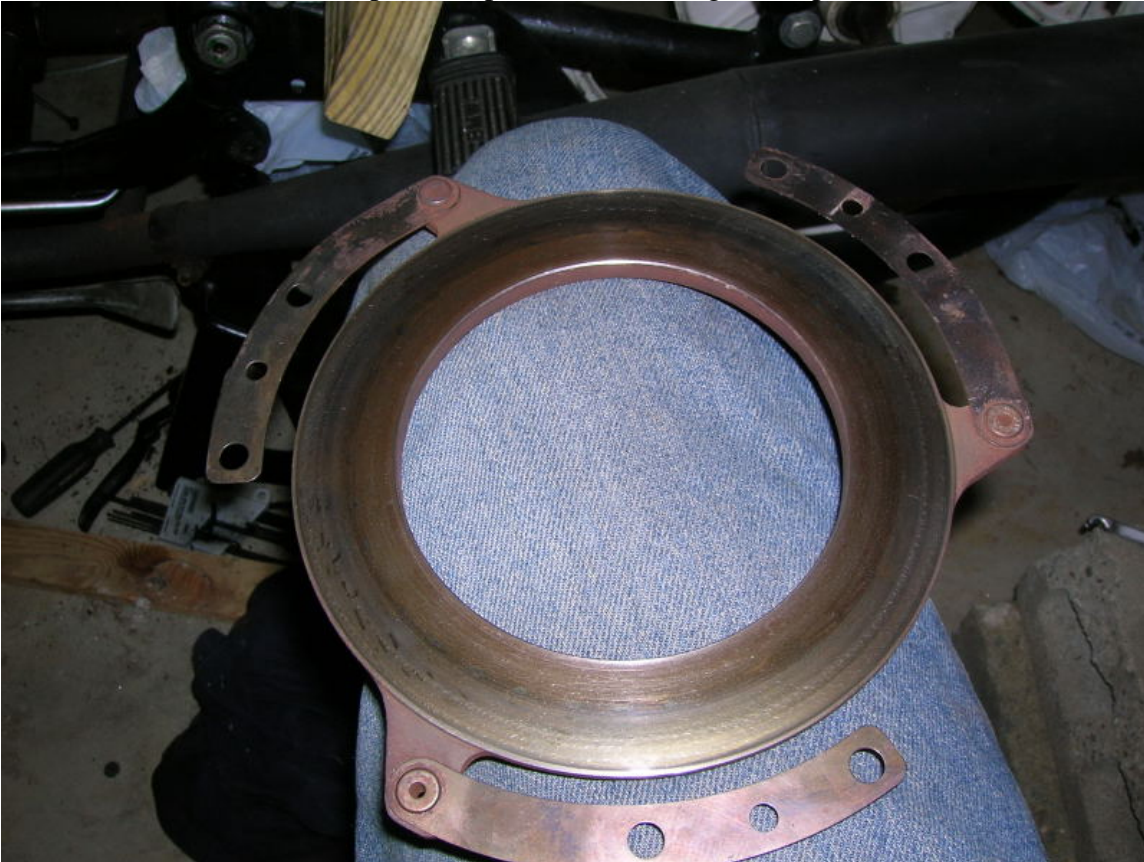
<insert Clutchjob21.jpg>

Here is the clutch friction or pressure plate, which will go on top next –

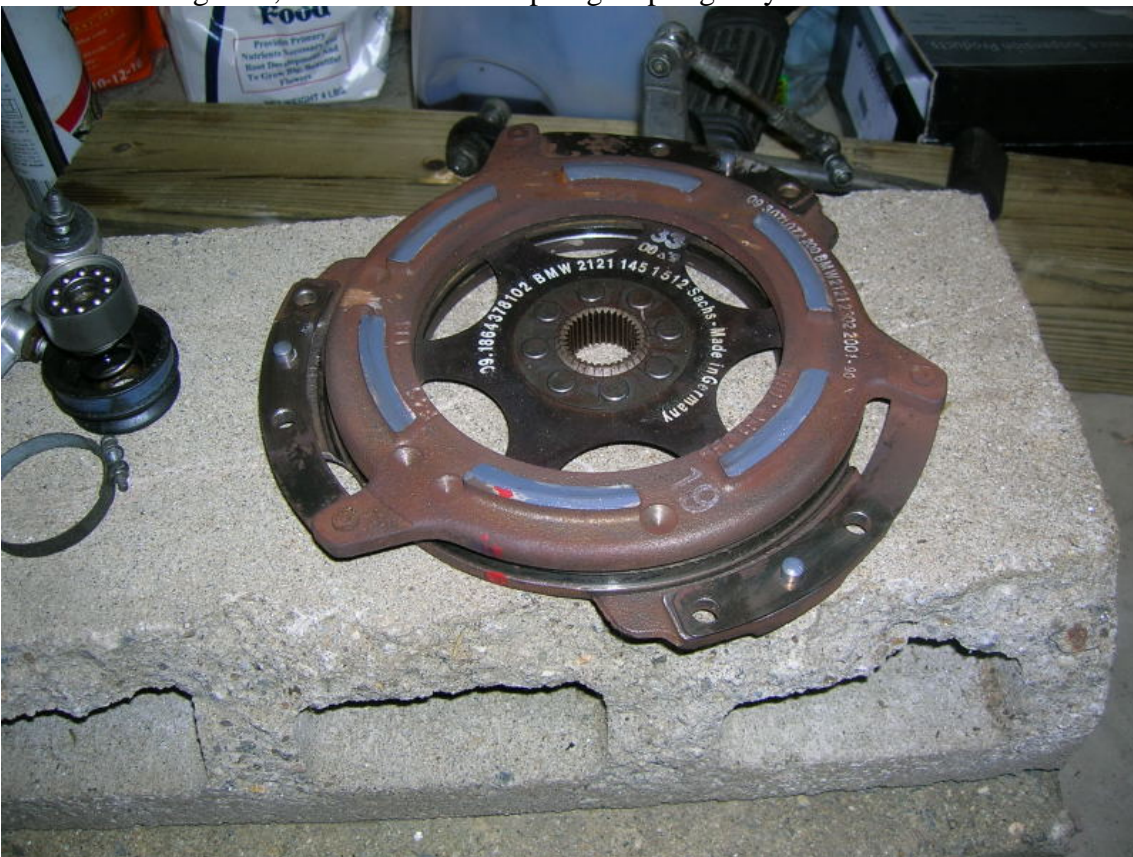
<insert Clutchjob22.jpg>

And “fitted” together, but without the diaphragm spring on yet:

The areas which show up as a bluish color are areas where BMW recommended a very light application of grease. These areas are where I applied a THIN film of Honda Moly-60, which shows up as blue in flash pictures, but which doesn't have this shade under normal lighting. Note that the red paint alignment marks are again in proper orientation from factory.

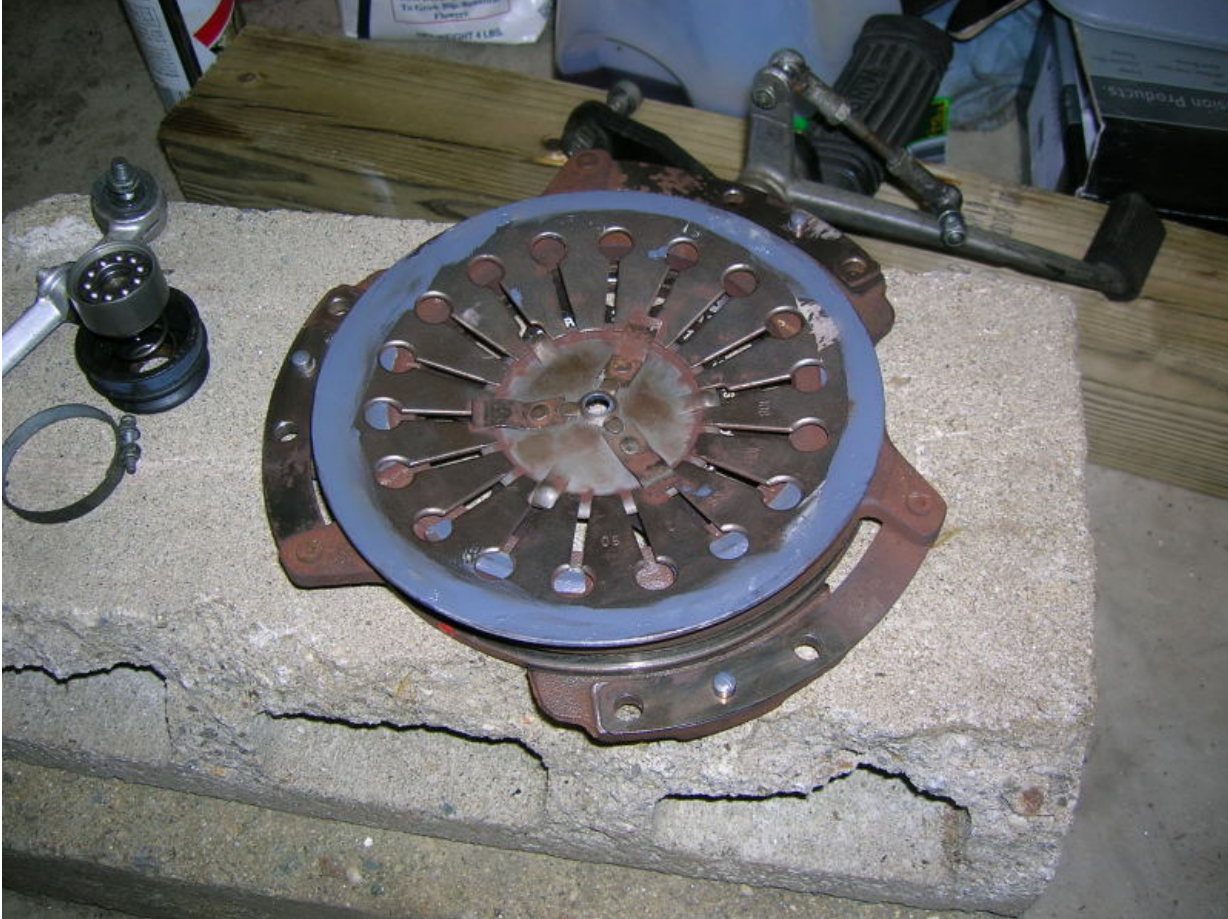
<insert clutchjob23.jpg>

And now, the diaphragm spring. Per recommendation, a very light film of grease is applied to the outer edge which will go against the flywheel. Now, with the flywheel design of the '81 and later airheads, the flywheel won't contact all of this area, but we'll do it anyway, just be sure to only use a little bit of sticky grease!

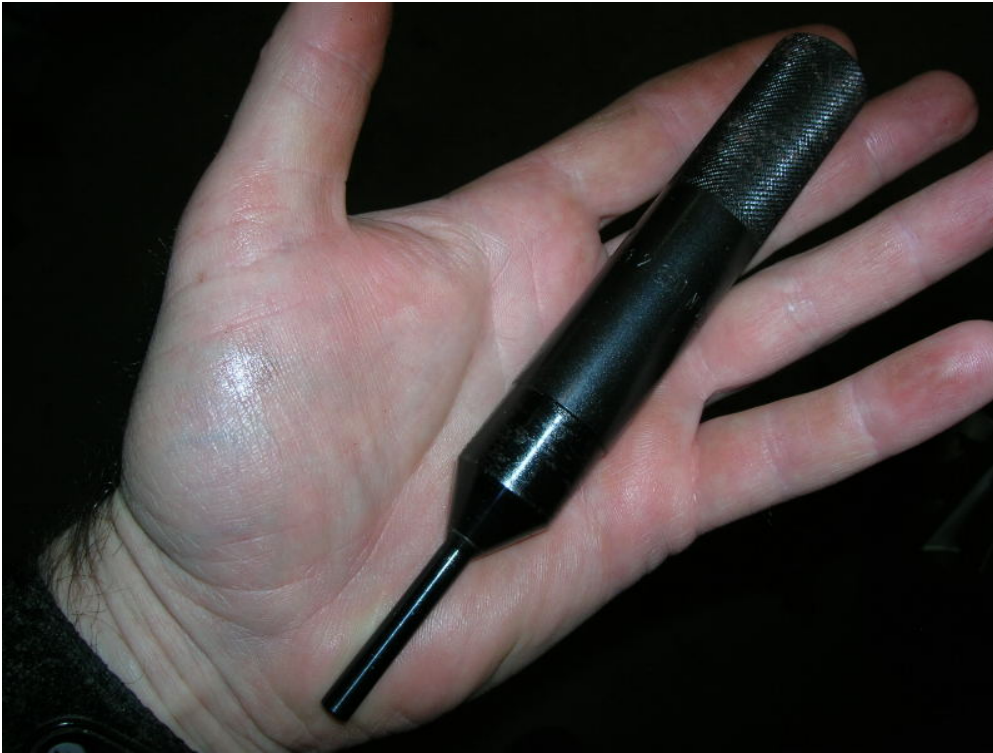
<insert CenterArbor.jpg>

We will put the parts back in place, using a special tool – a “Clutch Centering Arbor”. I have heard that there is a VW automobile arbor tool which will also work, but I sprang for the official BMW one to be sure. It is possible to put everything back together without one, but if things aren't centered well enough you won't know that you have issues until you are trying to get the transmission back on – not a good time to find that things don't quite slide together. I would recommend using the tool – everything went back together perfectly for me and I was doing this job alone. Someone handy with a metal lathe could also turn out one of these tools easily, I think.
