Clutch disk replacement and transmission input spline lubrication

The following outlines the steps that I took when removing the transmission from my 1982 R65LS and replacing the clutch disk – I also ended up replacing the transmission with a rebuilt unit as the input shaft splines had been heavily damaged from the clutch spline failure experienced on the road and under power. These same basic steps (but stopping short of disassembling and removing the clutch carrier assembly) can be used for performing regular transmission input shaft spline lube. I would recommend that a proper spline lube be performed on any BMW airhead at least every 3-4 years or 20K miles, or perhaps more frequently if operation in severe conditions is common. If you have a “new” bike without recent documentation history of having this done, or you buy a bike (which may still have very low mileage) which has been stored for years, I would recommend doing this as soon as possible.

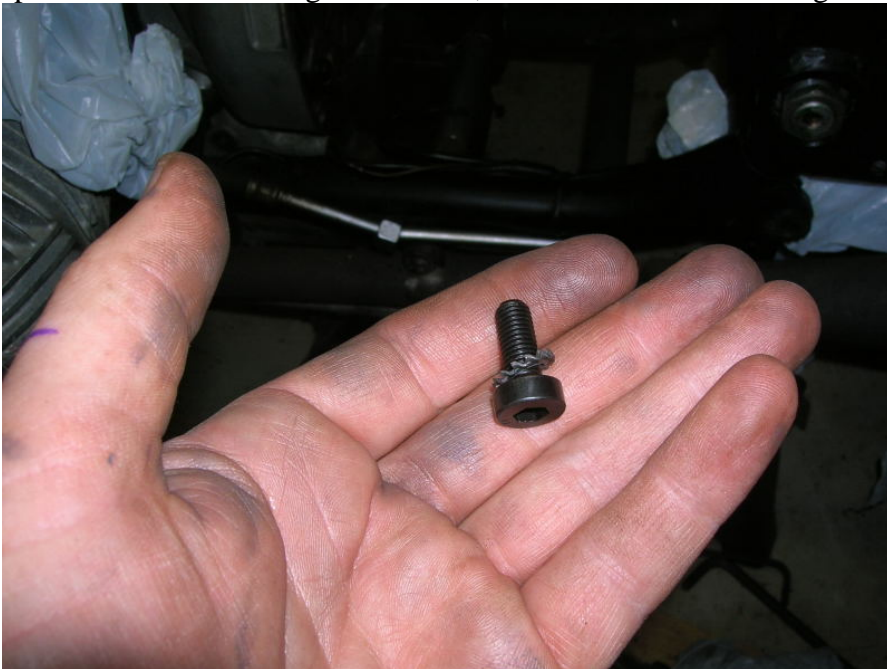
<insert Clutchjob24.jpg>

As previously mentioned, we use the (3) long bolts to start compressing the diaphragm spring and getting things positioned so we can start the NEW (short) regular bolts. These bolts are not stretch bolts and do have a special wave washer to go with them, but BMW recommends against re-use (plus the old ones do get rusty)

Here we have the assembly in place with the (3) long bolts. The centering arbor was inserted fully into the assembly before the bolts were installed to ensure that all the plates/disks/springs are centered. Note that we've positioned the red alignment marks to line up with the mark on the flywheel as it was originally.

We will install (3) new bolts&washers, and then remove the (3) long bolts and replace them with (3) new bolts and washers. Evenly tighten all bolts in a cross pattern to 20-22 N-m or 15-16 ft-lbs with a torque wrench, and I do this in (2) stages (first to 10ft-lbs, finally 15 ft-lbs) to ensure that I am evenly compressing the diaphragm spring fingers. Once all bolts are tight remove the centering arbor.

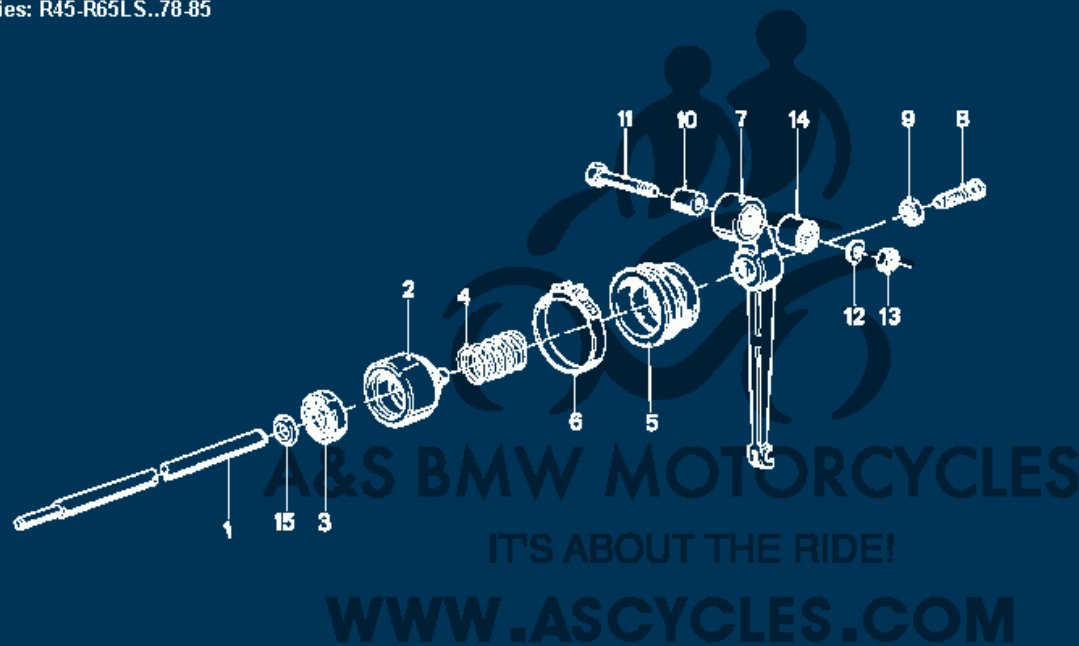
Diagrams 21_0086 CLUTCH CONTROL
Series: R45-R65LS..78-85

Now, we must carefully clean, inspect and relube the clutch pushrod and throwout bearing assembly. Unfortunately I had a camera problem at this stage and don't have any good pics of this, but I will at least include an exploded diagram of the parts. Clean everything in a good degreaser and blow dry with compressed air. We will lubricate the bearing (radial roller bearing on pre-81 models, captive ball bearing on 81-later models) and piston with 80W-90 Hypoid gear oil – or whatever you are using in your gearbox/transmission.

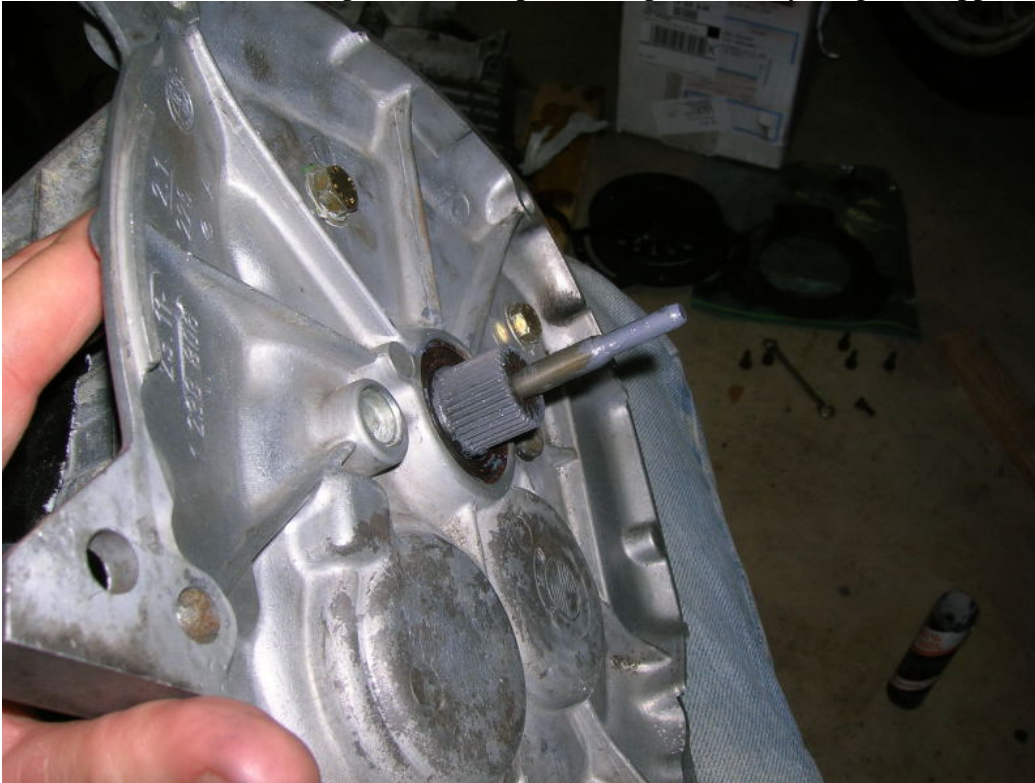
<insert Clutchjob27.jpg>

Here is the transmission input shaft and pushrod tip with Moly-60 grease applied:
